# Voltage Dip Ride Through Testing for Dynamically Positioned Vessels

OneStep Power Solutions Inc.  
Jan 2020

# Repeatable and Safe Voltage Dip Ride Through Testing for Dynamically Positioned Vessels.

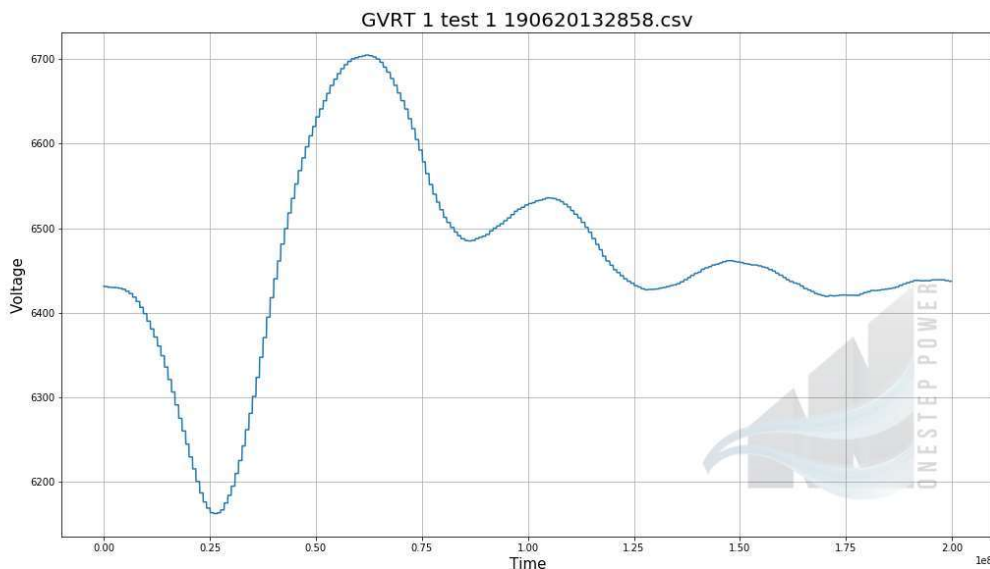
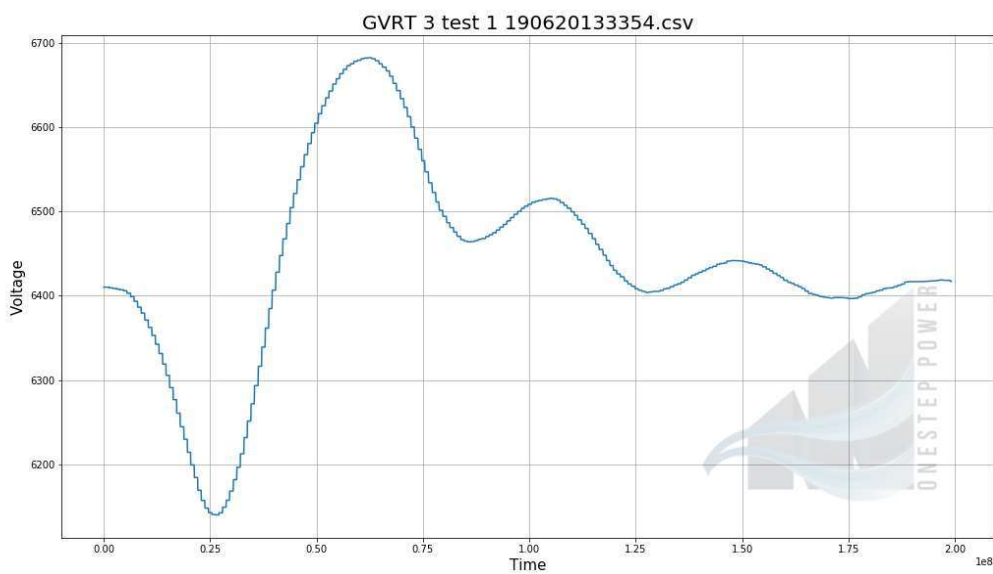
Initially two of the 5.3 MVA units were tested with the generator disconnected from the bus which resulted in an unstable response. As the new AVR had the ability to be set with multiple tuning parameters for operation online and offline, further testing was conducted with a single generator online. As can be seen in figures 10, 11, 12 and 13 the system voltage had a substantial overshoot when compared to the tests of the same time period on the sister vessel. The test that is shown in figure 13 resulted in an overvoltage alarm being generated on the power management system.

Figure 10. Test-01 (GVRT-1, DG-2) Results

Figure 11. Test-01 (GVRT-3, DG-4) Results

Figure 12. Test-02 (GVRT-1, DG-2) Results

Figure 13. Test-02 (GVRT-3, DG-4) Results

These graphs indicate the generator AVRs had an underdamped response that may not have settled to the required 3% within 1.5 seconds, as per ABS<sup>7</sup> and DNV<sup>8</sup>.

No further testing was conducted on this vessel and the vessel owner arranged for the AVR installer to return and re-tune the AVRs prior to commencing operations.

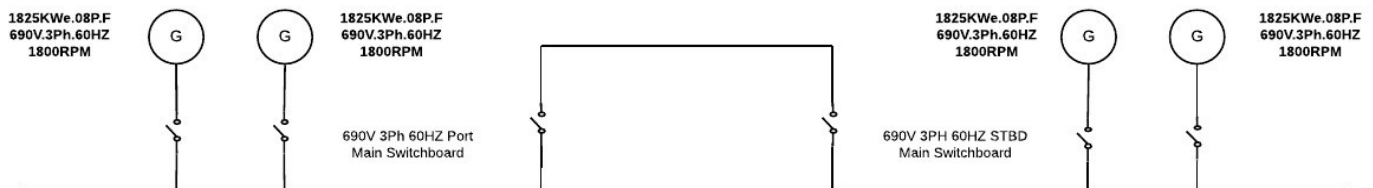
After discussions with and requests from industry it was decided to design and incorporate a method of forcing the bus voltage to zero for a controlled time. OneStep Power's ZeroDip was designed to provide an integrated solution for high-speed breaker switching during the transients induced by the GVRT. The third vessel discussed had two buses with four 1.8 MW 690 V generators, two generators on each bus, as shown in figure 14.

Figure 14. Power system of vessel 3

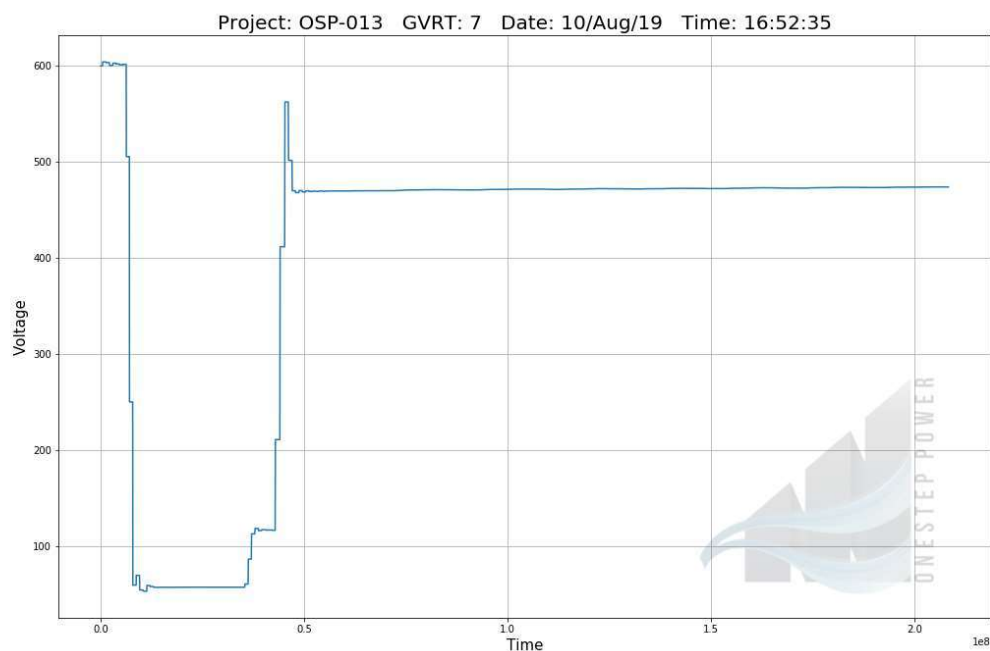
In order to prove a system's ability to ride through the voltage dip that would be experienced by the consumers during a three-phase symmetrical short circuit, the test duration was required to be greater than the bus tie circuit breaker trip times. The vessel under test had bus tie breakers set for 300ms. To be sure to account for possible delays a test time of 350 ms was selected for the test. In Figure 16 the bus voltage collapsed to zero and was reinstated approximately 350 ms later. While the voltage was restored to the 690 V bus, all 480 V, 208 V, thrusters and DP equipment was lost.

Note: the discrepancy in the voltage after re-application of the power was due to the open delta transformers being unevenly loaded caused by the loss of equipment after the voltage interruption.

Figure 16. Waveform of Test-02

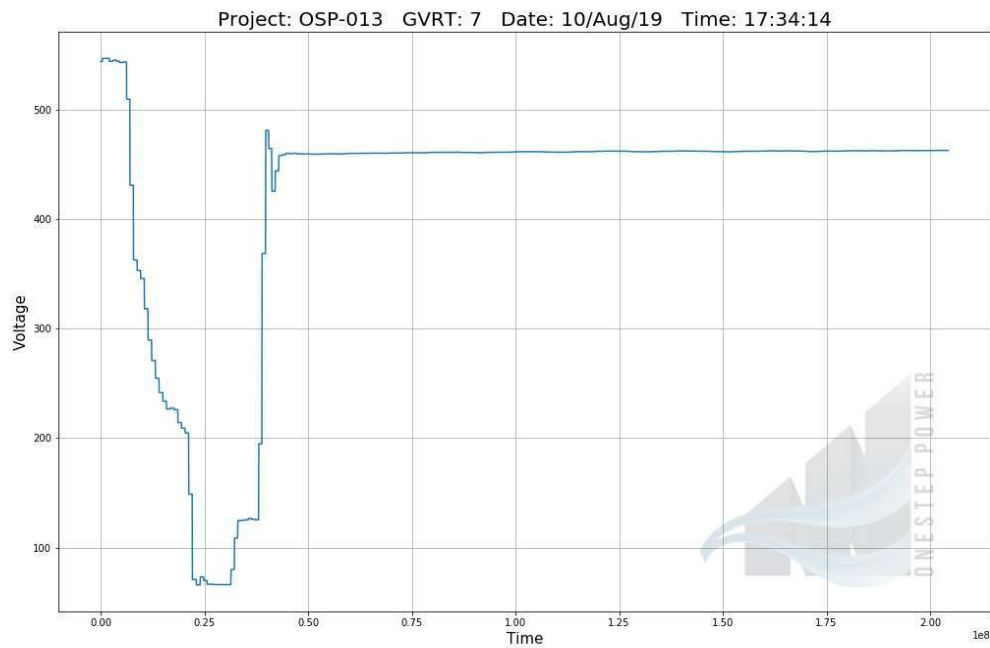
As the vessel failed a 350 ms test, the time was reduced to 310 ms to ascertain if the system would ride through a loss of voltage for 300 ms. The test of 310 ms, shown in figure 17, also failed with the loss of all 480 V, 208 V, thrusters and DP equipment.

Figure 17. Waveform of Test-03

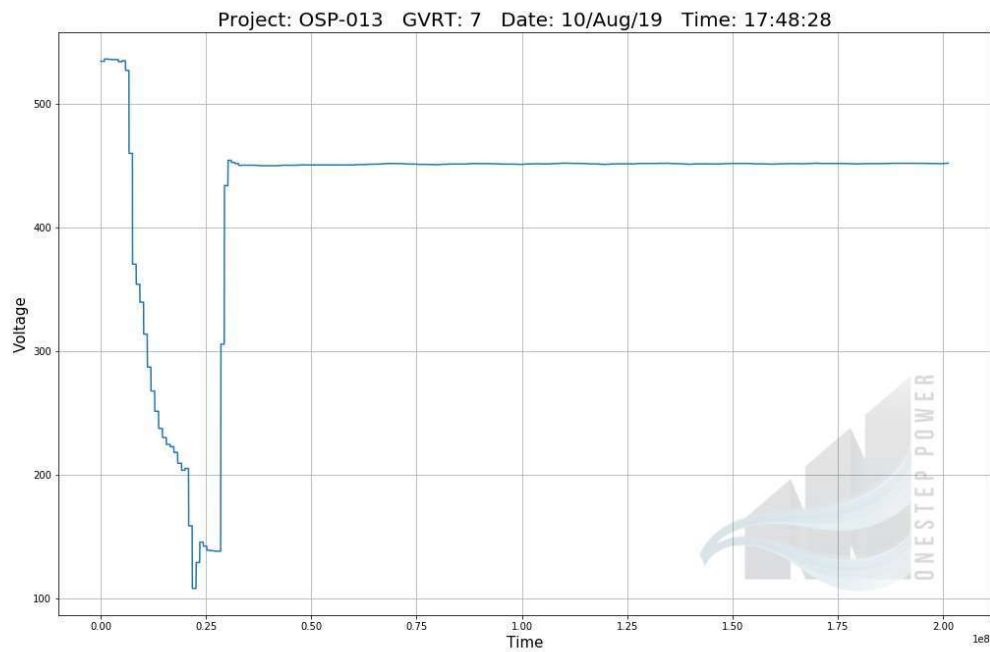
To verify the system response the test time was reduced to 200 ms. This test is shown in figure 18. Again all equipment from the 480 V bus and down was lost.

Figure 18. Waveform of Test-04

Further testing was halted as a combination of voltage dip followed by transient overvoltage would result in a failed test and no further useful information would be gained.

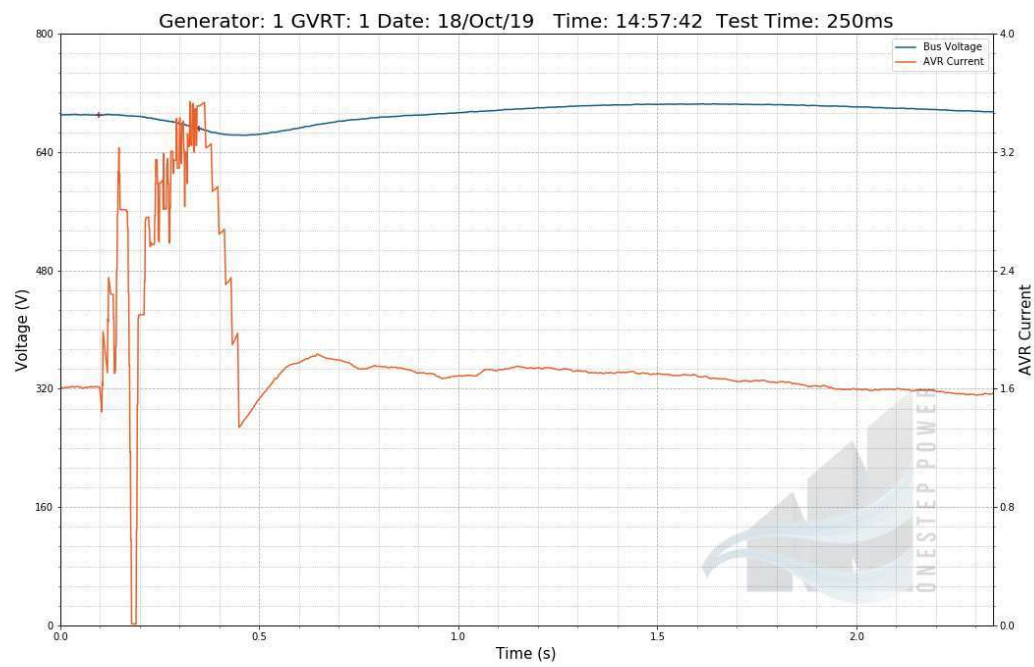
All generators were tested disconnected from the bus and were found to have good responses and no instability. Once the generator responses had been verified as acceptable, each generator was connected to the bus individually with bus ties open and tests conducted to confirm system and consumer responses on each bus. The first test was conducted for 250 ms and the result shown in figure 20. All generators and buses demonstrated similar responses with no loss of DP equipment.

Figure 20. Results of Test 01, Generator #1 250 ms open bus

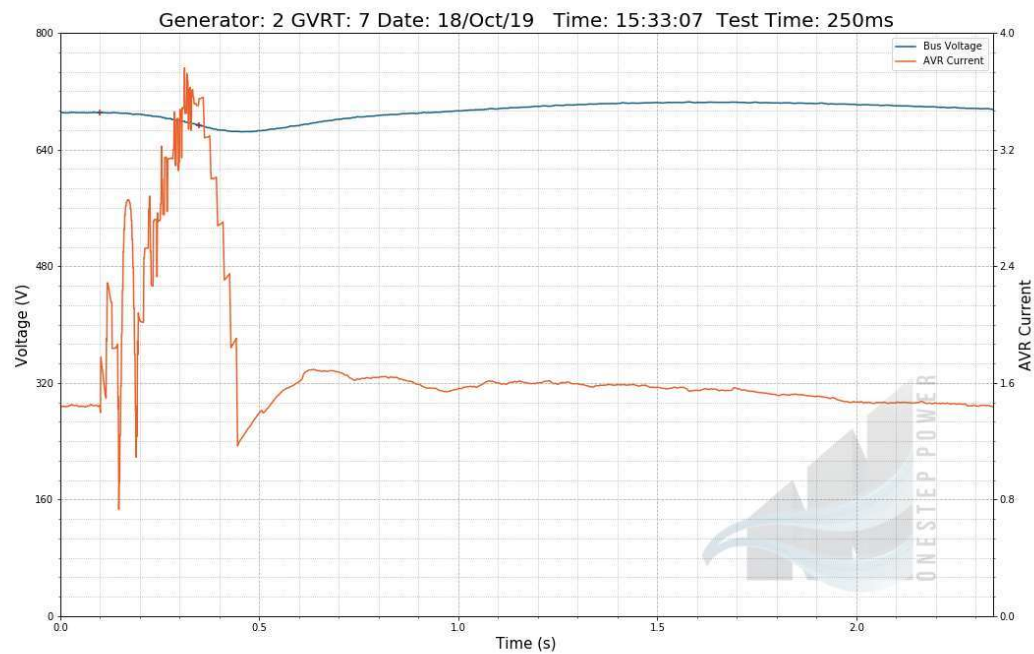
The second generator was connected and the system was tested in closed bus. Figure 21 shows that the response was similar to the responses from the open bus testing with no loss of equipment.

Figure 21. Results of Test 02, Generator #2 250 ms closed bus
